Dawlish Warren Beach Management Scheme

March 2017

Monthly project update

Phase 1 of gabion basket removal completed, revetment works begin, and groyne deconstruction underway

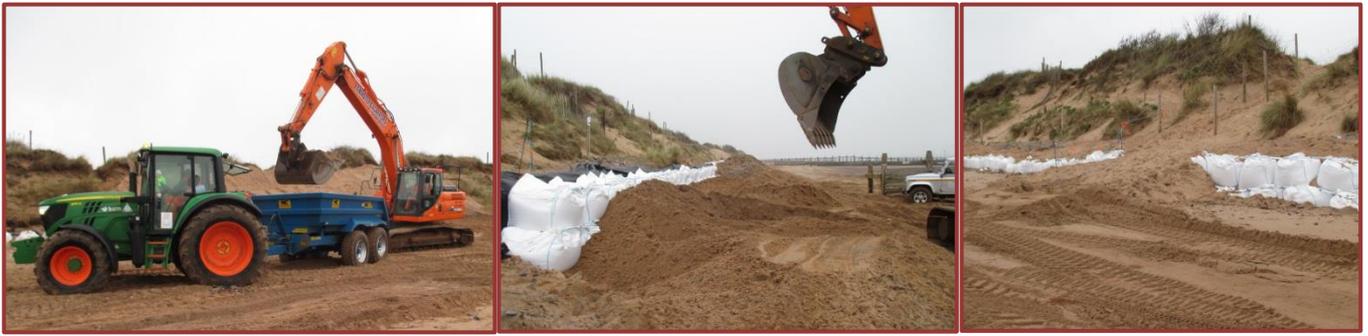
The first phase of work to remove the stone filled gabion baskets was completed this month. The existing stone filled gabion baskets were installed along the length of the dune face at Dawlish Warren. The baskets were failing in numerous places and preventing the dune from behaving naturally. Sand lizard translocation works were completed in 2016 to allow the first phase of removal works, from groyne 2 to groyne 8, to be completed with no risk to the internationally protected lizard species.

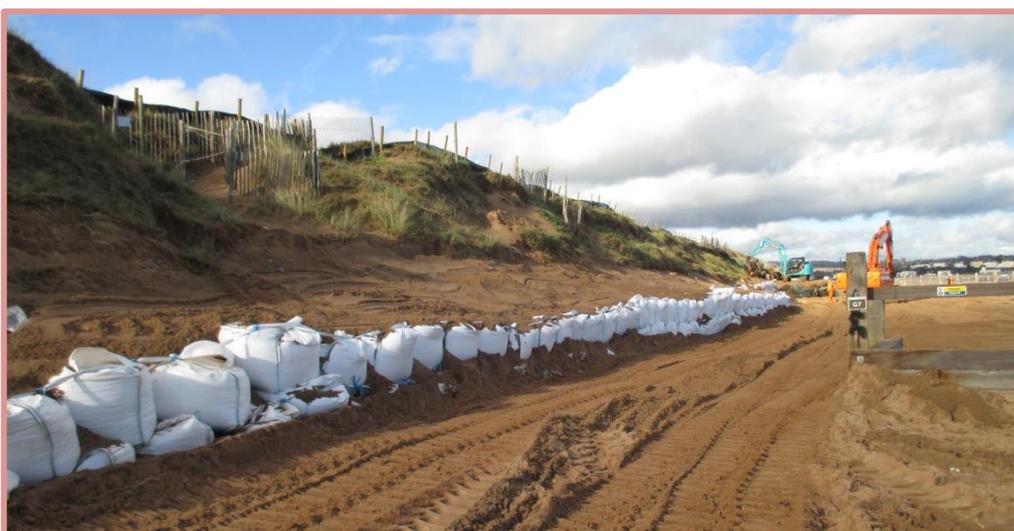
In order to minimise erosion of the dunes before the beach recharge in the summer, temporary protection measures have been put in place. Temporary sand filled bags have been placed in front of the dunes. These bags will be removed before the beach recharge. Wherever safe to do so, beach access points have been reinstated.

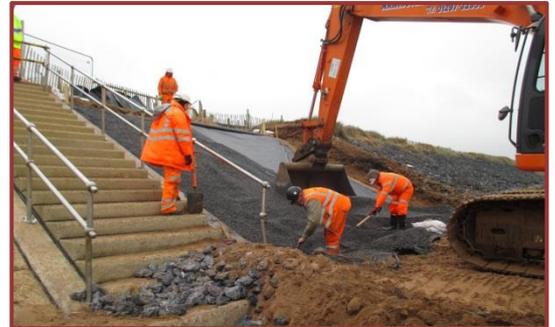
New Revetment between groynes 2 and 3

Works began this month on the new revetment. Porous concrete units are being placed to form a new revetment from the steps at groyne 2 to east of groyne 3.

As part of the revetment works, later in the year new steps will be installed east of groyne 3, replacing those damaged by storms in February.
